HIGHWAY ACCIDENT REPORT

MULTIPLE VEHICLE COLLISION WITH FIRE DURING FOG
NEAR MILEPOST 118 ON INTERSTATE 40
MENIFEE, ARKANSAS, ON JANUARY 9, 1995

SPECIAL INVESTIGATION OF COLLISION WARNING TECHNOLOGY

**Adopted: December 4, 1995
Notation 6530A**

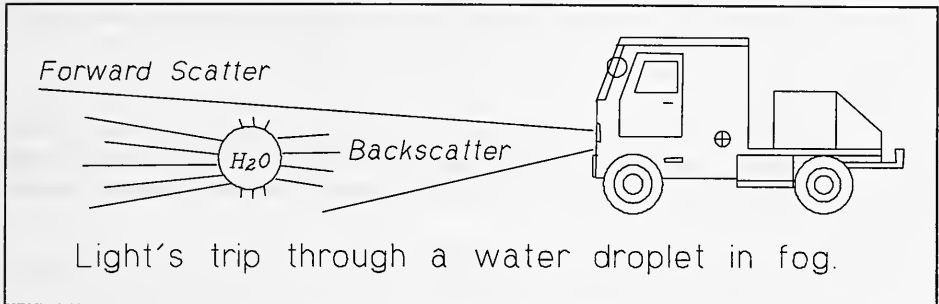
Figure 3. -- Water droplet effect on light transmission.

How does fog affect incident illumination, whether daylight, headlights, or fixed lighting? Figure 3 illustrates light interaction with a single water droplet. Molecules and particles of any kind will scatter light waves or photons, changing their direction of travel. Larger particles will scatter more light. Scattering by a single water droplet, such as those that constitute fog, will peak in the forward direction (away from the light source). Most light energy is scattered in the forward direction away from the light source with a significant few scattered off to the side in a rainbow effect as well as back toward the light source.

Smaller drops scatter more in the backward direction proportionally compared with larger drops; hence, fog with smaller drops restricts driver visibility more at night because more of the headlight luminance is scattered back towards the driver. The trip of each photon through a fog bank involves many collisions and reflections. Referred to as multiple scattering, it will eliminate any spectral selectivity or rainbow effect due to single scattering. So the effect is: when you put white light in, you get white light out; when you put red light in, you get red light out. The color of the light does not affect its ability to penetrate fog.

Backscattering by raindrops reduces contrast. Headlight luminance transmitted in any direction is reduced by raindrop scattering, meaning that the total amount of light reaching objects is less (see figure 3). Specular or mirror-like reflections from the road will increase markedly, which increases the glare and driver distraction.

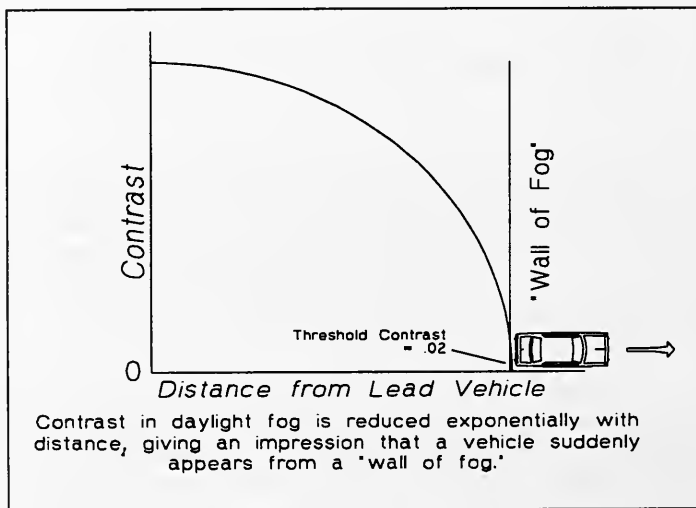
Figure 4. -- Illustration of the "wall of fog" effect.

Light transmission through fog of a given density is reduced exponentially with distance from the light source. (See figure 4.) Therefore, the driver may perceive that the visual range created by his headlights suddenly hits a "wall of fog" ahead when the fog is of relatively uniform

density. Likewise, as its contrast with surroundings becomes suddenly perceptible, an object hidden by the fog may often seem to suddenly appear from nowhere. Fog may also significantly affect driver depth or distance perception. Objects that appear hazy under normal conditions can be interpreted as far away. Therefore, the presence of fog may either cause drivers to misjudge following distances and closing speeds or cause delayed reactions to the perceived threat of a road hazard.

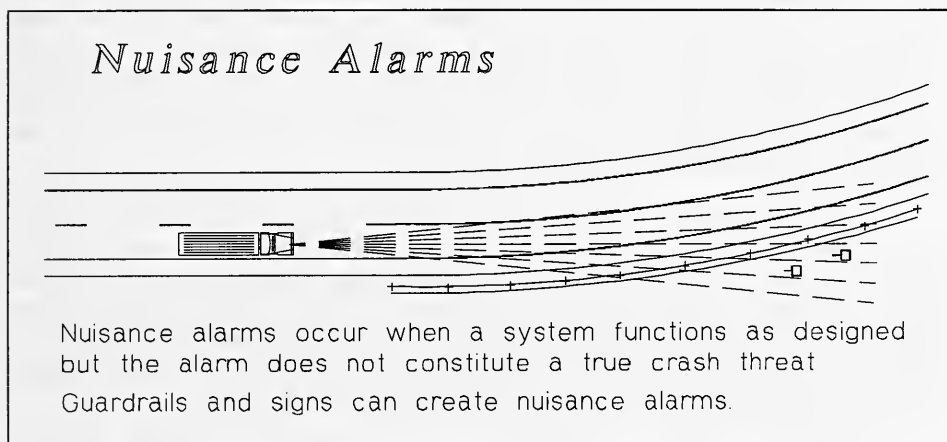
Figure 5. -- Illustration of nuisance alarm occurrences.

The modeling of these accidents included four possible HD system ranges (150, 200, 250, and 300 feet). The greater the system range, the greater was the possibility of nuisance alarms. However, this forward looking radar system would be theoretically designed to adjust the warning distance commensurate with the time and distance needed by the driver to avoid an obstacle at the varying speeds of the vehicle. Various algorithms were developed to define the operational characteristics of the hypothetical HD system. The warning distance is defined as the critical separation at a given speed at which the HD system would sound a warning if a crash threat were detected upon overtaking either a slower vehicle or a stationary object in the road. The dynamic warning distance refers to a mathematical equation for warning distance as a function of vehicle speed.

The lower the sensitivity of the HD system, the stronger the reflected signal must be to be detected, and the shorter the range at which the HD system will issue a warning. With low sensitivity, nuisance warnings are minimized, but a warning, when issued, may not afford sufficient time and distance for the driver to implement an effective evasive tactic. Conversely, the higher the sensitivity, the weaker the reflected signal that can be detected, and the longer the effective range of the HD system. Longer range, however, increases the likelihood that nonthreats will be reported as nuisance alarms. (See figure 5.) For instance, a 3-degree-wide beam will be largely confined to the 12-foot travel lane of the equipped vehicle at a 300-foot range. Still, at 500 feet or more, the beam will be striking objects outside the travel lane of the vehicle. (See figure 6.)
